# US Patent Application 10/644,220

## Copper-Nickel-Silicon Two Phase Quench Substrate

# Rim Failure Modes

# Rim Surface Failure Analysis

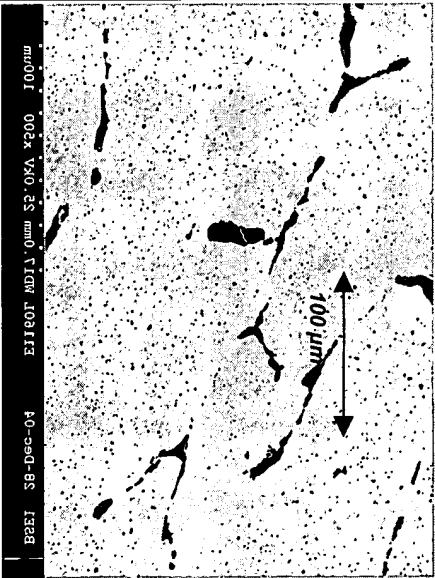
Microstructure
<b>Continuous Network</b> Recrystallized or Dendrite Cu Grains ~ 100 $\mu\text{m}$ diameter Silicides at Boundaries      >100 $\mu\text{m}^2$ Silicides Within Cu grains      <5 $\mu\text{m}^2$  Cells Between Silicides      ~ 1000 $\mu\text{m}$

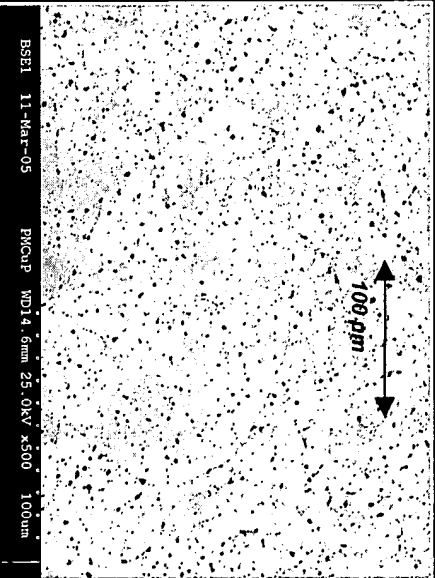
<p>100 <math>\mu\text{m}</math></p> <p>mi001 002x Vx0.35 mm0.11Gm 109113 40-350-85 1324</p>
<b>Discontinuous Network</b> Cu Grains =      ~ 50 $\mu\text{m}$ diameter  Silicides at Boundaries      <5 $\mu\text{m}^2$ Silicides within Cu grains      <2 $\mu\text{m}^2$

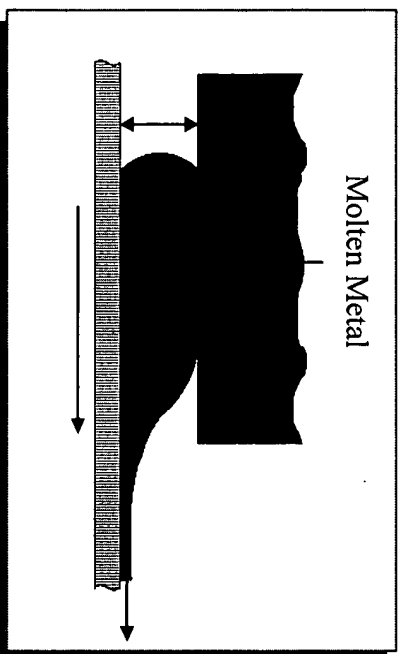
**Thermal Pulse** from casting molten metal onto the rotating rim

- Thermal Pulse Reduces Tensile Hoop Stress
- Average Rim Temperature ~ 300°C

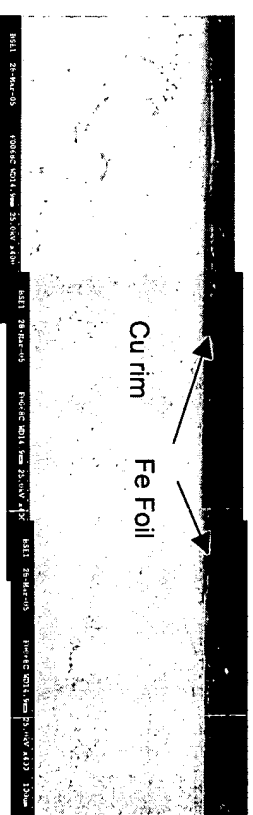
**Peeling** from welding/stripping

EDS Analysis:

5.11Cr-25.99Fe-30.07Ni-38.82Cu

Ni-Silicide

Crack

- Molten Metal Penetrates Rim Surface (at large Silicides?)
- Cu, Cr and Ni Dissolution in Fe
- Cracks Extend From Weldment

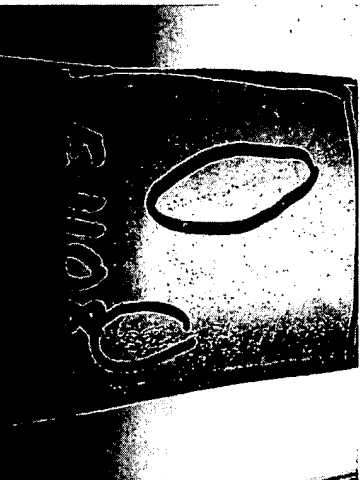
**Macro of Rim Surface  
Showing Scars**

Note: Scarring is localized.  
Significant "good" area.

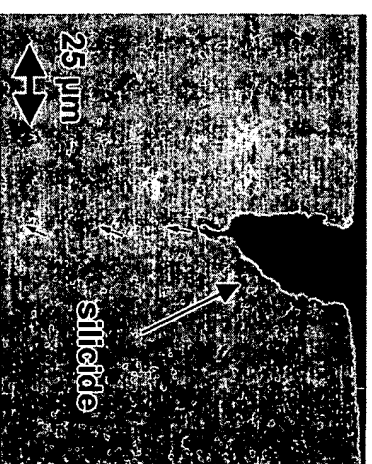
**Micro Cross Section of Rim  
Showing Pit and Silicides**

Note: Individual pit is small.  
Silicide is large (>5μm thick)

*Rim Failure Related to Non-Homogeneous Microstructure*

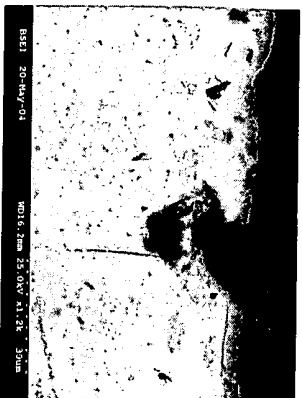
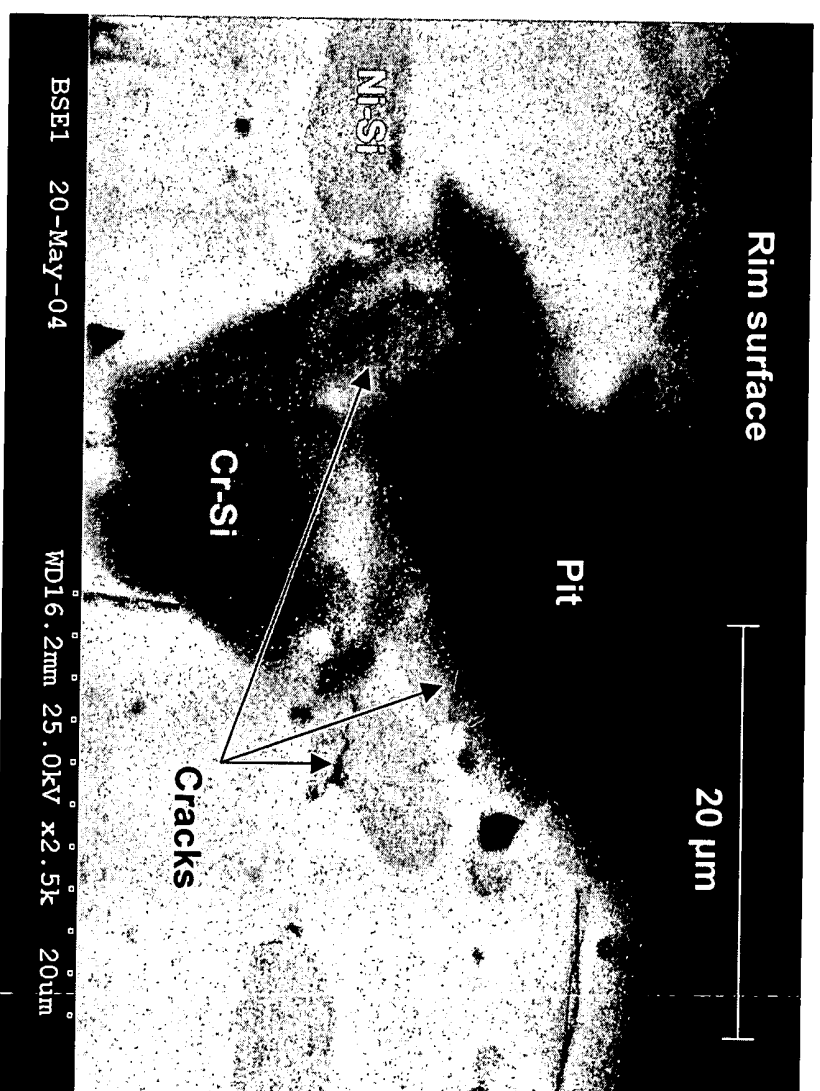
## SEM – Transverse Section

*Sub-surface Crack Networks Can Create Pits...  
Pits Can Expand Thru Continued Cracking*

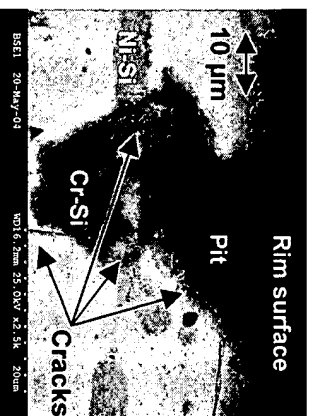
*Pit Formation via Crack Nucleation and Growth through Large Primary Silicides*

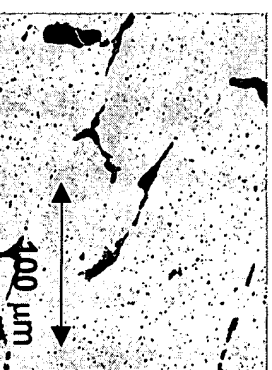
Continuous Network Rim  
Grain Size ~ 100 μm  
Silicide Size up to 500 μm<sup>2</sup>

*Rim Surface Degrades via Cracking Through Large Silicide Particles  
No Large Silicide Particles in Discontinuous Network*

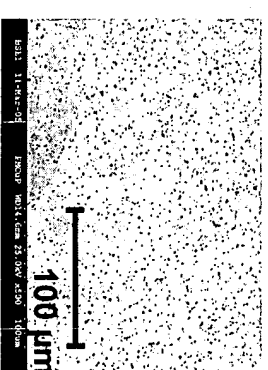
Discontinuous Network Rim  
Grain Size ~ 50 μm  
Silicide Size ~ 5 μm<sup>2</sup>

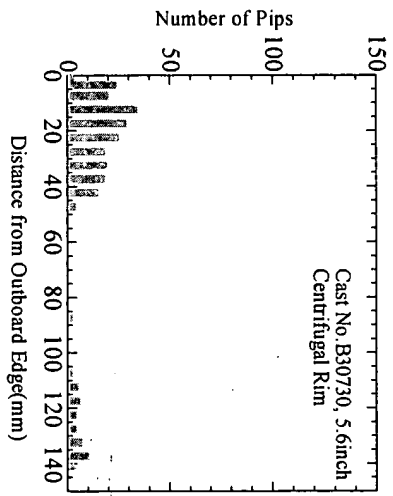
Continuous Network  
Rim

More than 50 defects

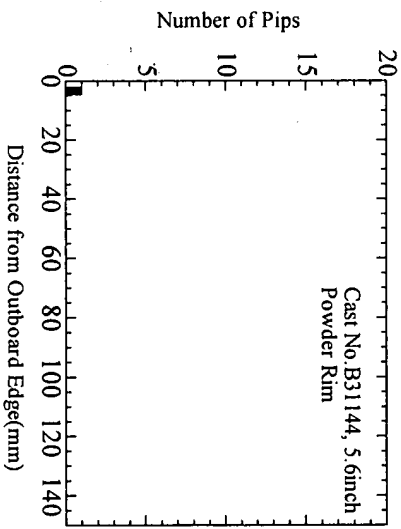
Discontinuous Network  
Rim

Less than 5 defects

Discontinuous Network Rims Exhibit Reduced Defect Formation, Improved Quality
